**Energy Research and Development Division
FINAL PROJECT REPORT**

**IN-LINE INSPECTION TECHNOLOGY
TO DETECT, LOCATE, AND
MEASURE PIPELINE GIRTH WELD
DEFECTS**

A Field Demonstration

FEBRUARY 2015
CEC-500-2015-028

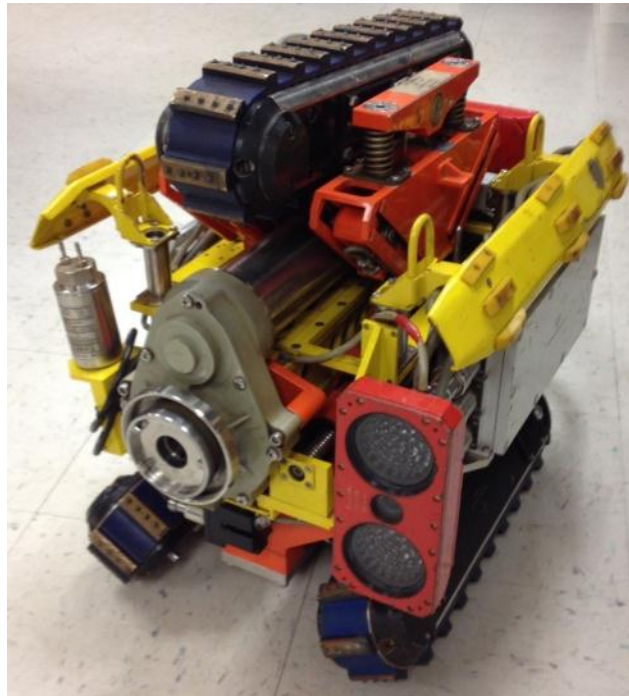
Figure 1: RODIS Crawler

The Remotely Operated Diagnostic Inspection System (RODIS) is a class of crawler-type robotic in-line inspection (ILI) tools developed by Diakont Advanced Technologies, Inc. (Diakont) for detecting, characterizing, and measuring pipeline anomalies, and for surveying pipeline features. Figure 1 shows a front view of a RODIS crawler; note the socket on the front of the crawler where technicians install modules to perform different functions during an inspection. (For images of the crawler with modules attached and inside pipes, see Section 3.2.)

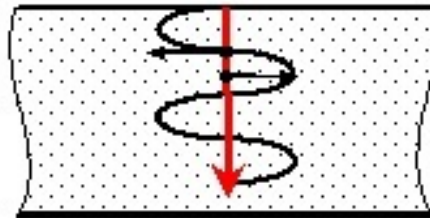
Figure 2: Shear Wave Initiation in a Test Object

During a UT inspection using shear waves, a non-destructive examination (NDE) tool initiates shear waves on the material surface. These shear waves cause vibration in the inspection object, where the vibration direction is perpendicular to the direction of the wave. Figure 2 shows a diagram of this process, where the red vertical arrow represents the shear wave created by the tool and the black horizontal arrows represent the resultant vibrations in the inspection object.

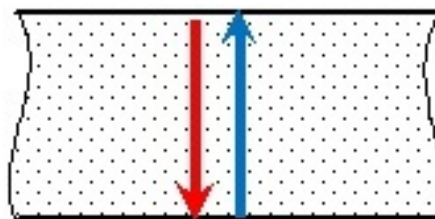
Figure 3: Shear Wave (0° Angle) Initiation and Reflection

The waves reflect from the opposite wall of the inspection object back to the point of origin. The residual thickness of the object is determined by measuring the time that elapses between initiating the original wave and receiving the reflection. Figure 3 shows a diagram of this process, where the red arrow at left represents the propagation of the ultrasonic wave initiated by the tool and the blue arrow at right represents the propagation of the wave reflected from the opposite pipe wall.

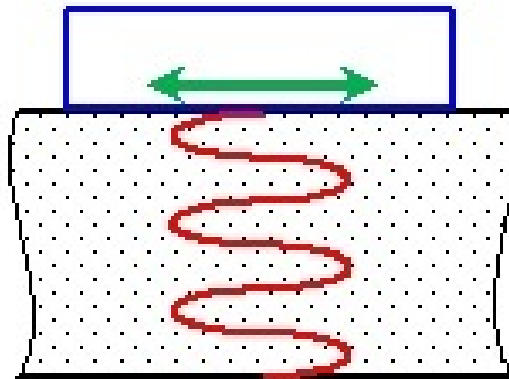
Figure 4: Piezoelectric Ultrasonic Wave Initiation Example

In the piezoelectric method, electrical voltage deforms a transducer. The resulting transverse vibrations are mechanically applied to the inspection object and generate the ultrasonic wave inside of it, perpendicular to the pipe surface. Figure 4 shows a diagram of this process, where the blue box represents a normal-incidence ultrasonic wave transducer, the green horizontal arrow represents the transverse vibrations, and the red wavy line represents an ultrasonic wave (in this case, a shear wave) created by the tool.

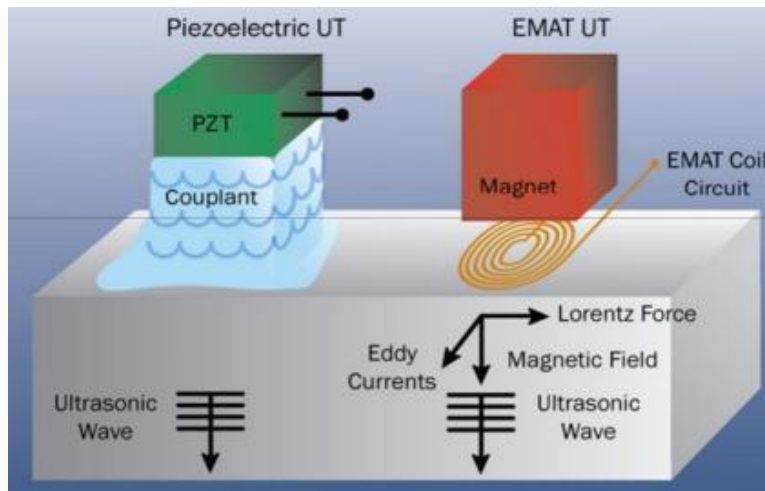
Figure 5: Detailed EMAT UT Method Diagram

The EMAT transducer contains a coil and a magnet. When alternating current flows through the coil, an eddy current is generated in the inspected material. The interaction of this eddy current with the transducer magnetic field creates a Lorentz force in the surface layer of the metal. This Lorentz force is transmitted to the atomic matrix of the inspection object through electron collisions to generate ultrasonic shear waves with the same frequency as the current in the coil. Figure 5 shows a detailed diagram of the EMAT inspection method.

In Figure 5, note that the eddy current moves along the z axis of the inspection object. For example, Figure 6 shows a front view of a RODIS tool during an EMAT inspection; in this figure, the eddy current from Figure 5 would move forward (out of the page, away from the crawler) while the Lorentz force would move circumferentially through the pipe wall.

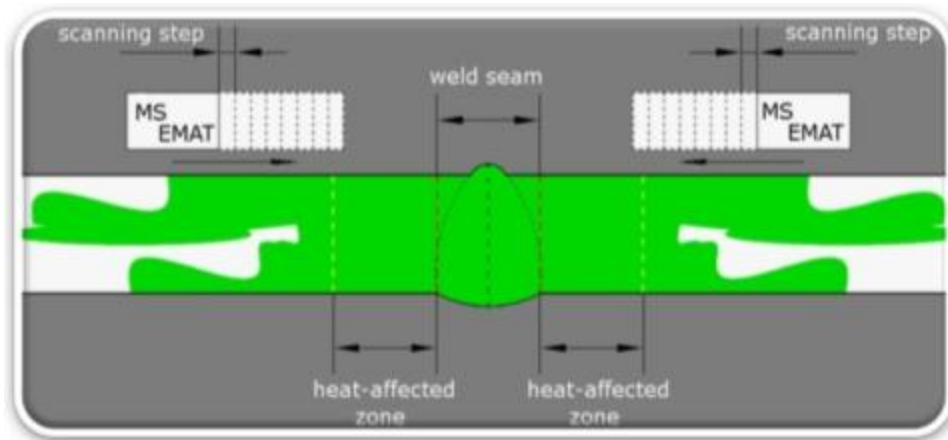
Figure 7: Multi-Channel EMAT Scanning Steps

Figure 7 shows a diagram of the GWS module's inspection area, where the green portion of the pipe wall represents the propagation of shear waves in the inspection object.

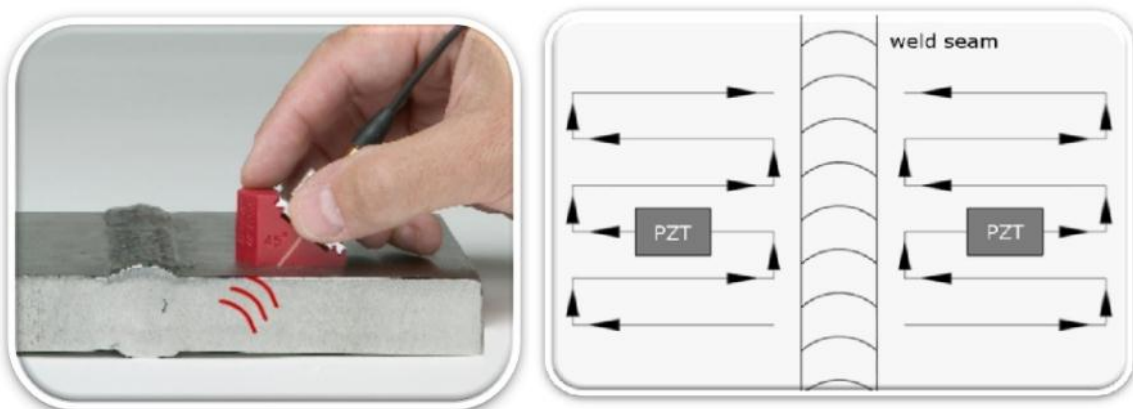
Figure 8: Piezoelectric Weld Inspection

Figure 8 shows a traditional piezoelectric weld inspection using angle beams. At left, the inspector moves the transducer in a meander pattern through the inspection area, along the path shown at right, inspecting the girth weld and the HAZ in three dimensions, using the principles described in Section 2.1.3.

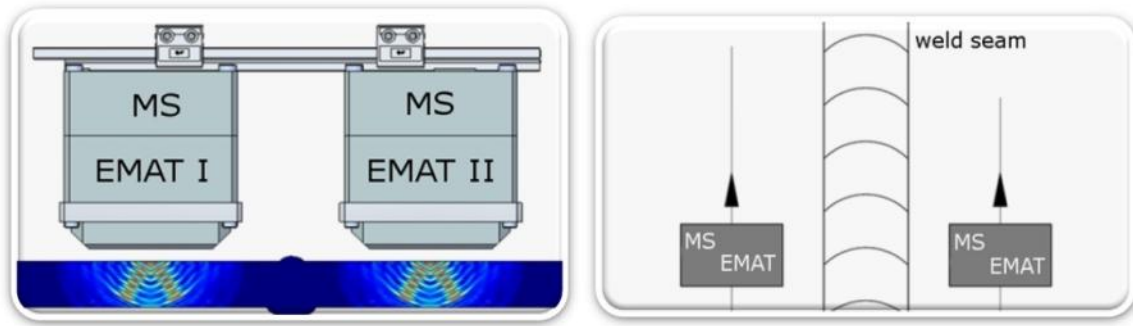
Figure 9: Diakont Multi-Channel FT EMAT Weld Inspection

Figure 9 shows the principles of Diakont's multi-channel FT EMAT inspection method. At left, the transducers generate shear horizontal arrays of ultrasonic waves alongside the girth weld; at right, the inspection module moves the transducers along the length of the girth weld.

This use of multi-channel FT EMAT technology with arrays of transducers allows for three-dimensional inspection of the girth weld and heat affected zone without requiring mechanical movement of the transducers in a meander pattern.

- Due to the transducers generating waves in multiple directions (as shown in Figure 9 and explained in Section 2.2.1), some defects that present as false calls during a girth

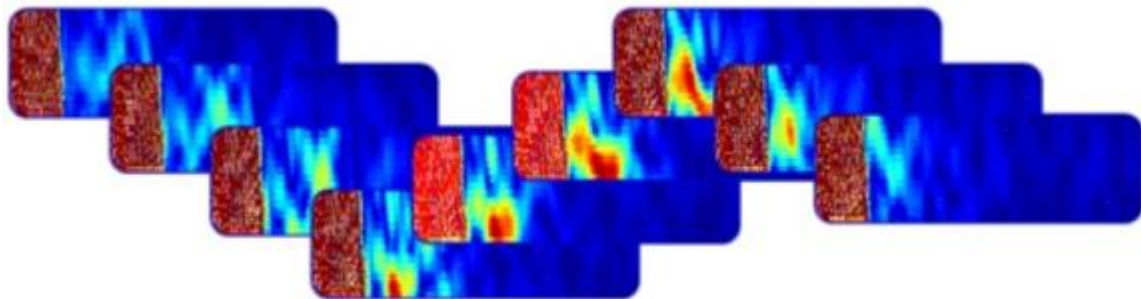
Figure 10: Complete Set of Individual FT Scans

The primary display shows echoes using FT scans. Different frequencies correspond to different input wave angles, and a set of nine FT scans is generated per step on each side of the weld during a weld inspection. Figure 10 shows a complete set of nine individual FT scans from one step of a weld inspection in a test pipe.

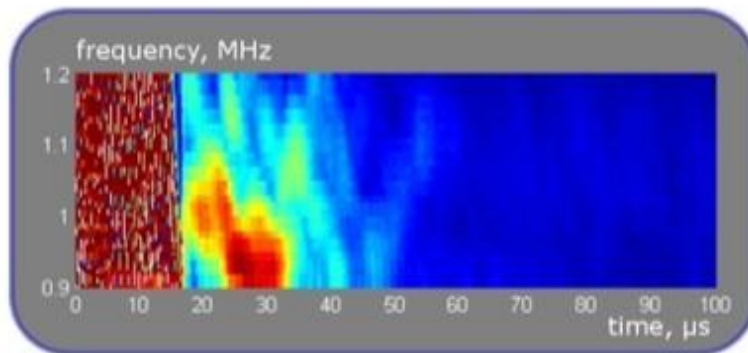
Figure 11: Frequency-Time Matrix Scan

Diakont's analysis software merges each set of FT scans into a single frequency-time matrix scan by sequentially overlaying the FT scans and selecting the optimal value at each pixel. Figure 11 shows this scan created by overlaying the FT scans shown in Figure 10, revealing a 0.079 in. lateral cylindrical hole in a test pipe with 0.906 in. wall thickness.

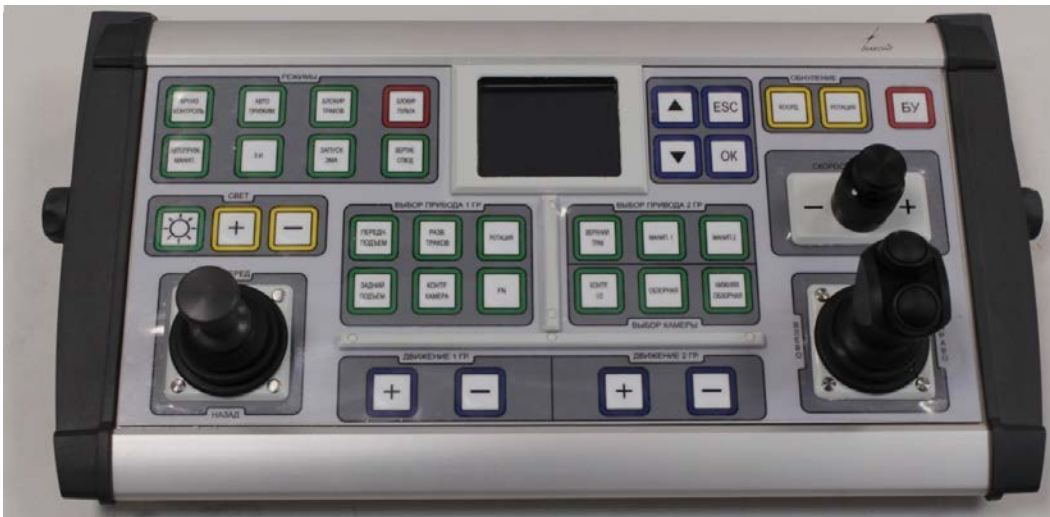
Figure 15 shows the new remote control unit specially designed to work with the new technology. The new unit includes upgrades to existing features as well as new features such as an LCD display and a module rotation speed control dial.

Figure 15: New Remote Control Unit

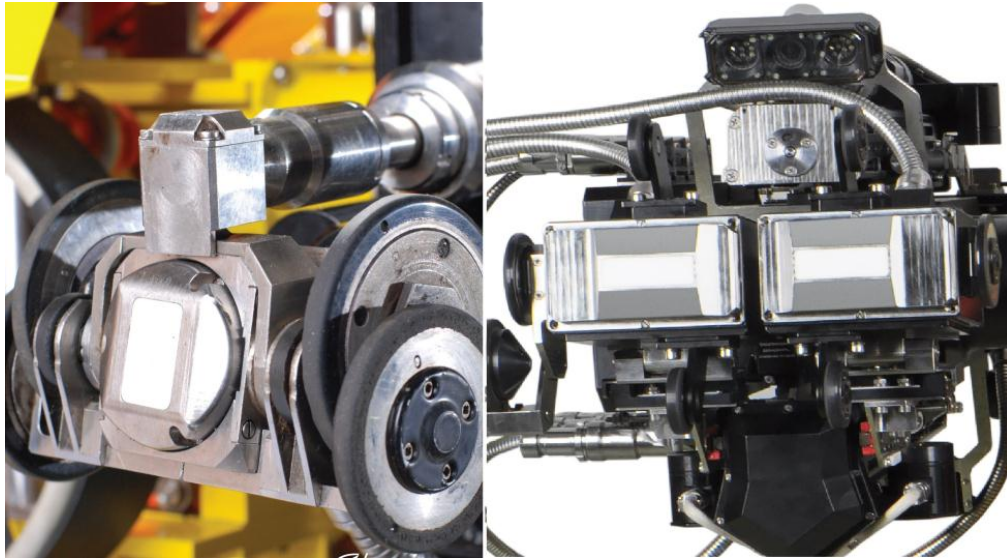
Figure 16: EMAT Transducer Comparison

Figure 16 shows the traditional EMAT transducer carriage at left and the GWS transducer carriage with transducer arrays at right. Section 2.1 details how Diakont engineers built off of traditional EMAT principles to develop a weld-scanning method and design the GWS module to implement it.

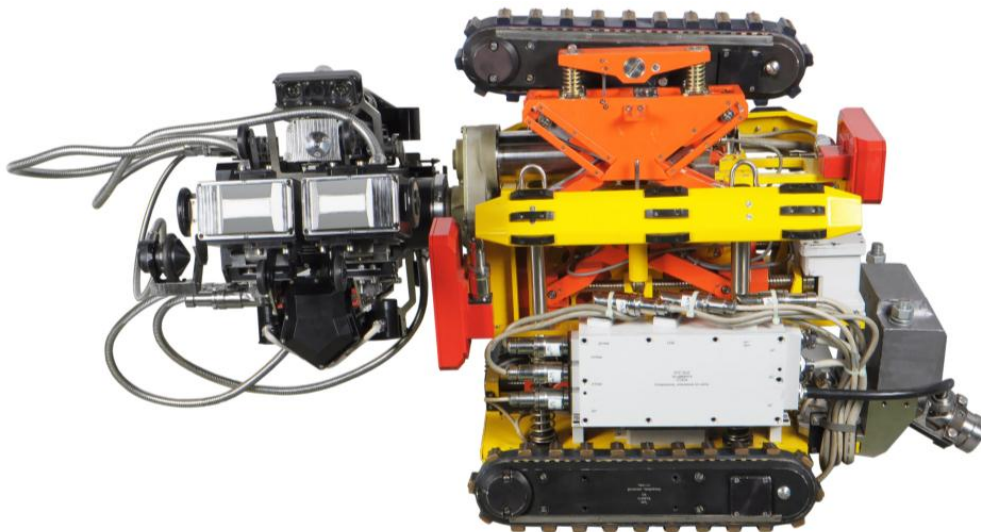
Figure 17: GWS Module Installed on RODIS Crawler

The EMAT module has a lower profile and is lighter than the prototype GWS module. One goal of this project was therefore to make the GWS module as slim as possible and realize similar operational parameters to allow Diakont to offer girth weld inspection services alongside other pipeline inspection services without mechanical restriction.

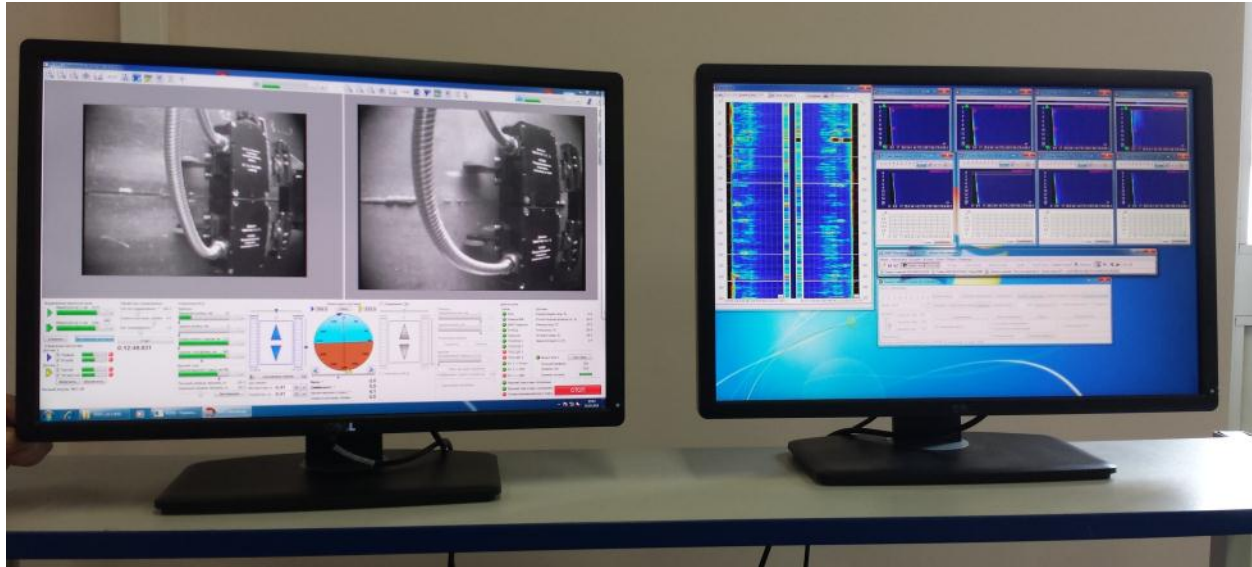
Figure 19: Control Station Display

Figure 19 shows the control station display used during a GWS inspection. The monitor at left shows the RODIS controls as displayed in Figure 18, while the monitor at right shows FT scans gathered by the tool as described in Section 2.2.2.

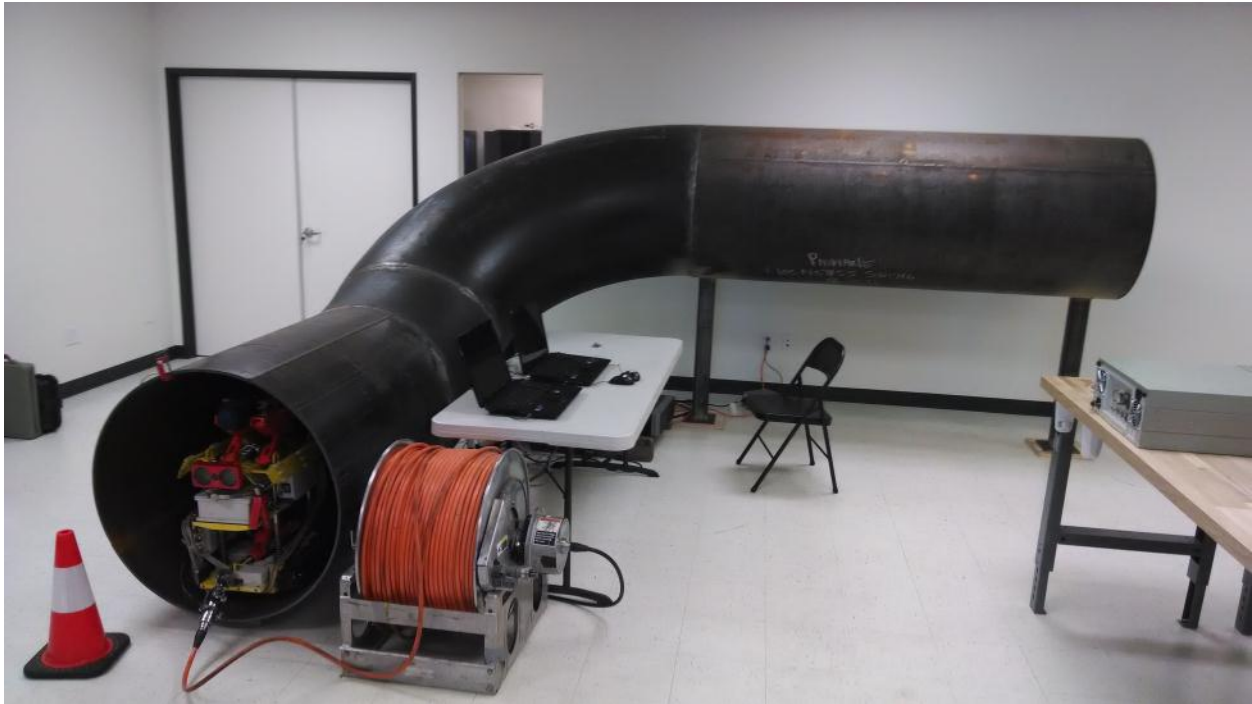
Figure 20: Horizontal Test Stand with Elevation Change and 90° Bend

Figure 20 shows a 36 inch outside diameter (OD) horizontal test stand located at a Diakont facility. This test stand includes both an elevation change and a 1.5D 90° bend (where 1.5D indicates that the turn radius is equal to 1.5 times the diameter). Technicians tested the RODIS from both ends, as shown below and in the high end of the test stand (at right in the figure), in order to optimize GWS module operation on an incline and in a lateral bend. The variation in entry heights also resulted in valuable practice inserting and removing the tool under a variety of conditions, making the technicians better able to adapt to unique field conditions.

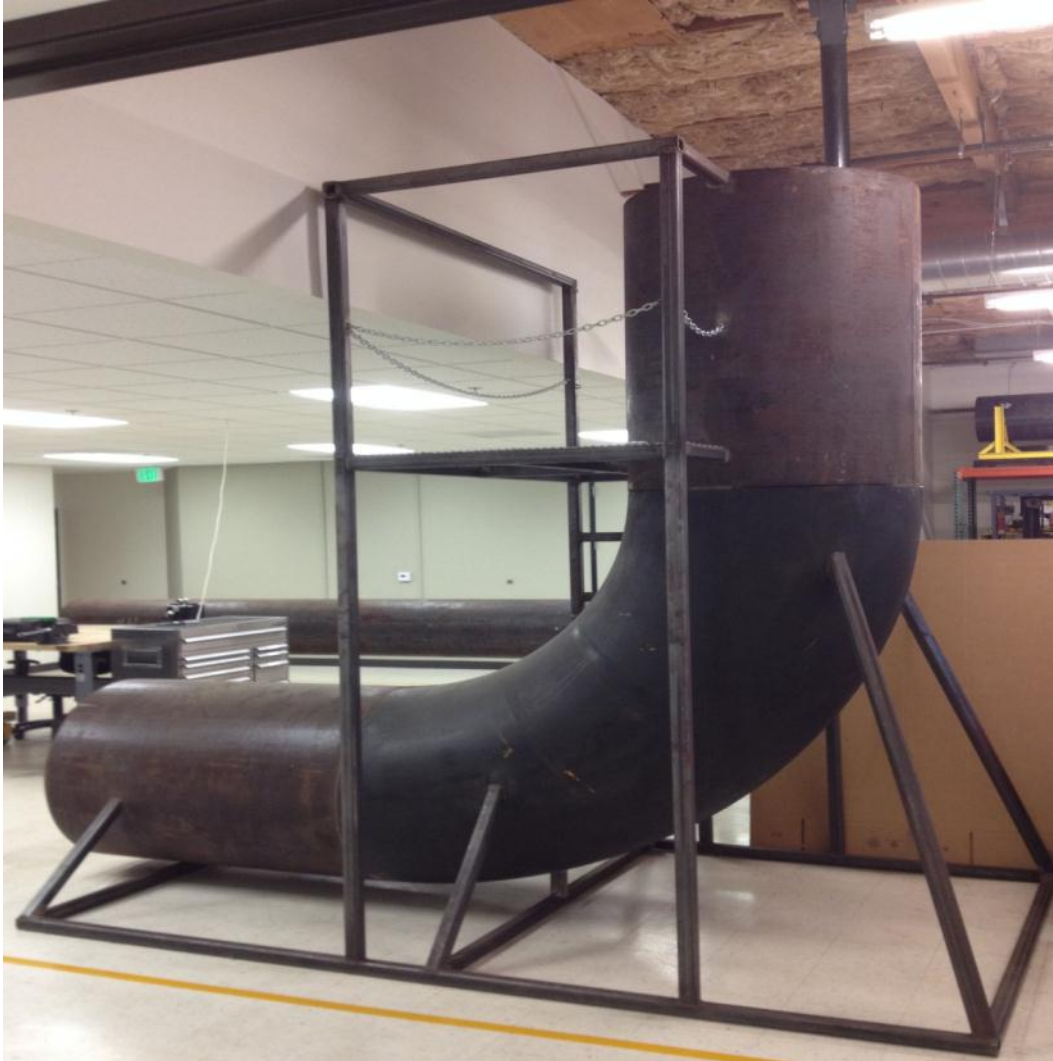
Figure 21: Vertical Test Stand with Sag Bend

Figure 21 shows a 36 inch OD vertical test stand with a 90° sag bend. Technicians tested the RODIS from both ends in order to optimize RODIS system operation in vertical pipelines and in sag bends as well as to practice critical safety procedures in a controlled environment.

Diakont typically uses a steel emergency retrieval cable when a RODIS tool is used in a pipeline with a significant downward angle, and technicians use an internally-designed crane to help load the crawler into vertical points of entry. Tests in the vertical test stand confirmed that this equipment is also appropriate when using the GWS module and helped optimize vertical loading techniques. This crane is visible in Figure 21 at the top of the test stand in the upper-right corner of the figure.

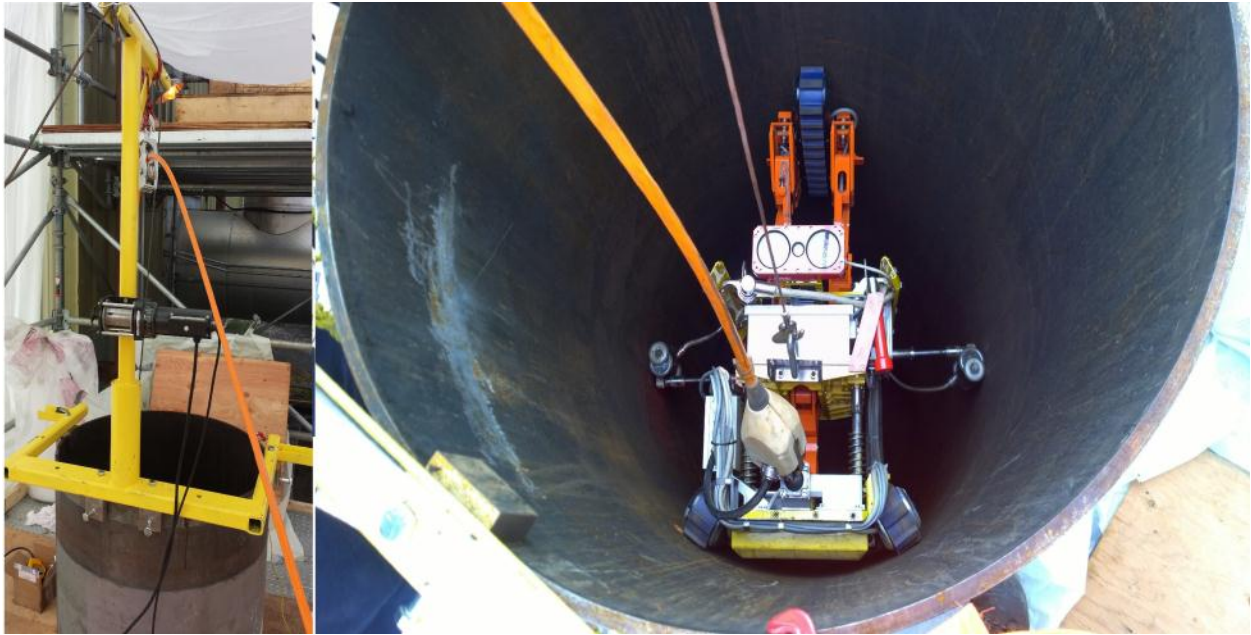
Figure 22: Portable Crane for Vertical Entry

Figure 22 shows a close-up view of the crane installed at left and a birds-eye view of vertical tool entry at right. Note the steel emergency retrieval cable anchored to the back of the RODIS; this cable is kept taut during a vertical inspection to prevent damage to the tool or the umbilical cable if the tool loses traction.

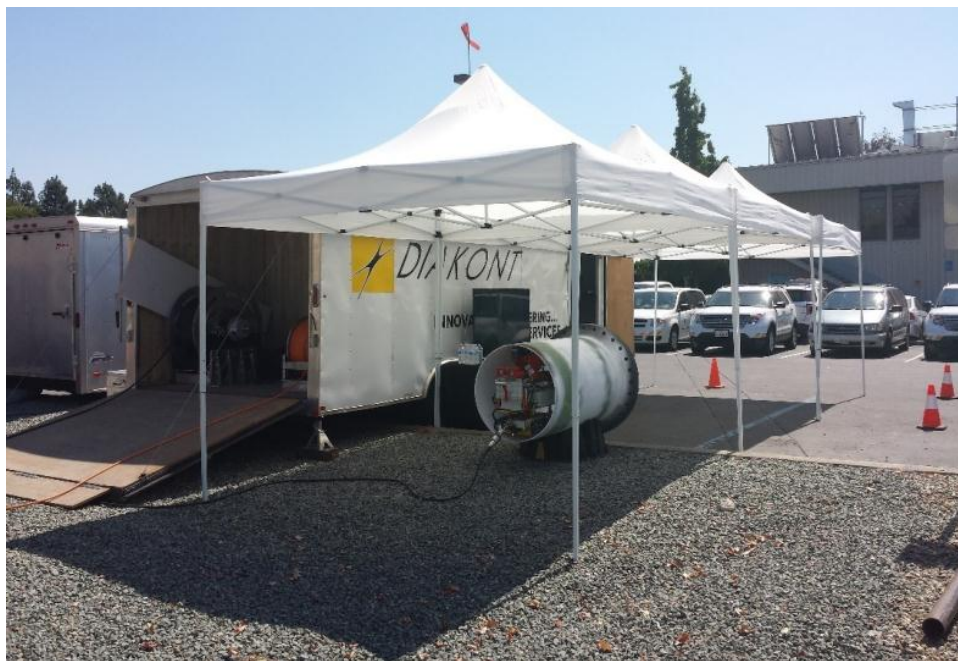
Figure 23 shows the inspection in progress. Note that the trailer functions as a control center as well as equipment storage and deployment; this figure shows the entirety of the work site fitting easily into six standard parking spaces, illustrating the versatility of the RODIS system.

Figure 23: Test Loop Inspection

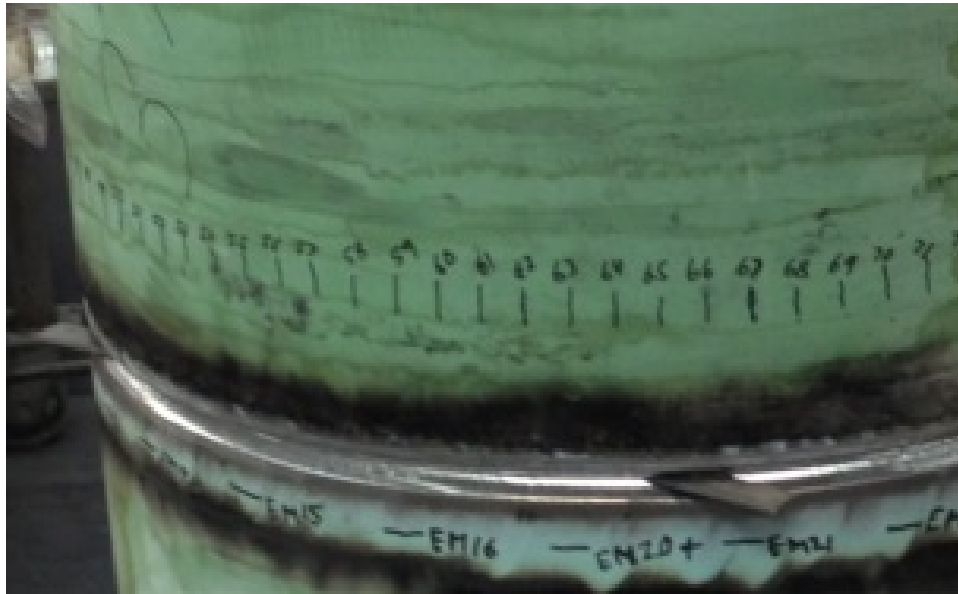
Figure 24: Test Pipe Close-Up

Figure 24 shows a close-up of the test pipe. Note the hash marks along the weld marking some of the pre-installed anomalies (e.g., EM16).

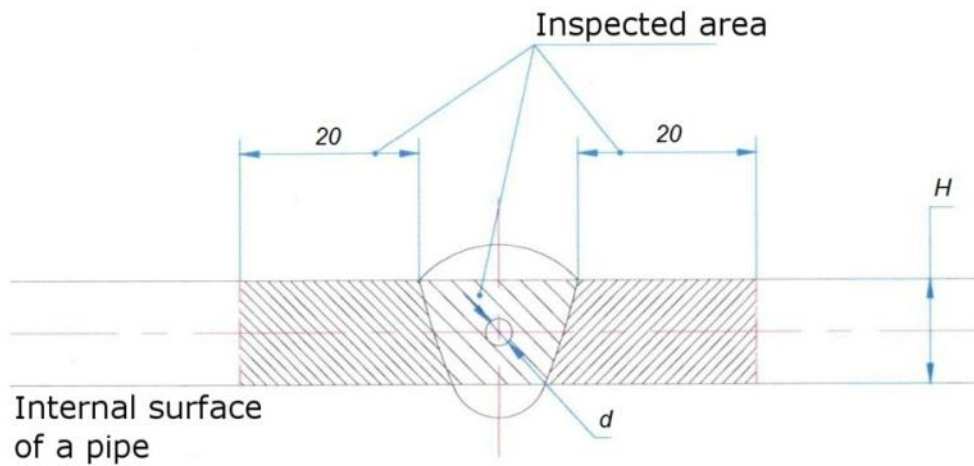
Figure 27: GWS Volumetric Defect Specifications

Figure 27 shows the inspection parameters for GWS detection of volumetric defects. For this figure, H represents pipe wall thickness and d represents defect diameter.

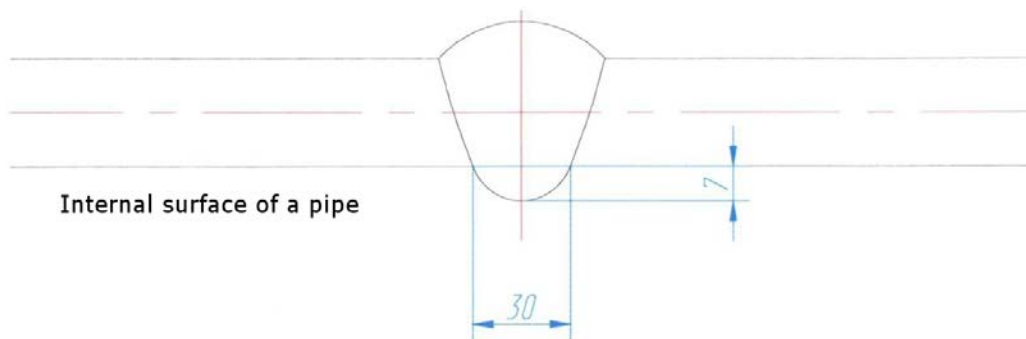
Figure 29: Defect Dimension Measurement Limitations

Figure 29 shows the maximum weld size that the GWS can examine.

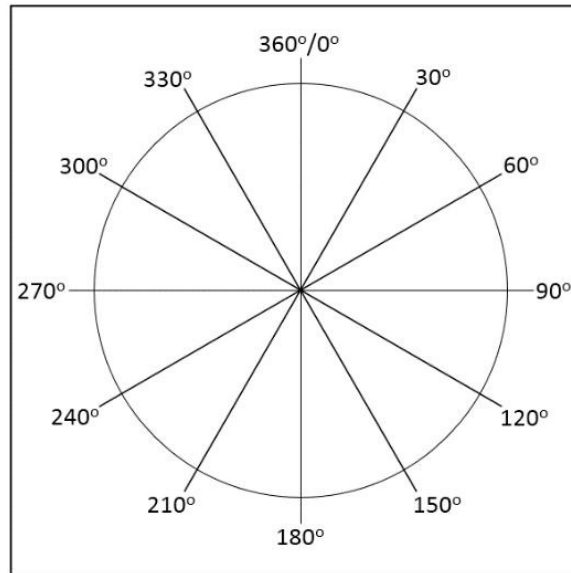
Figure 31: Degree Position Values of Circumferential Coordinates

Anomaly circumferential position is denoted in degrees, where 0 degrees corresponds to the top center. Circumferential positions provided are measured to the center of the anomaly. This measurement increases when moving clockwise while facing in the direction of the tool travel, as shown in Figure 31.

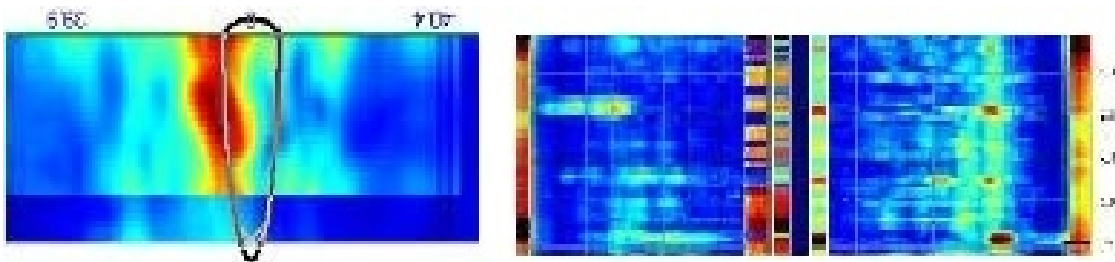
Figure 33: Thin Tube Defect

Figure 33 shows a thin tube OD defect. The GWS module accurately located and measured this anomaly during the tool run.

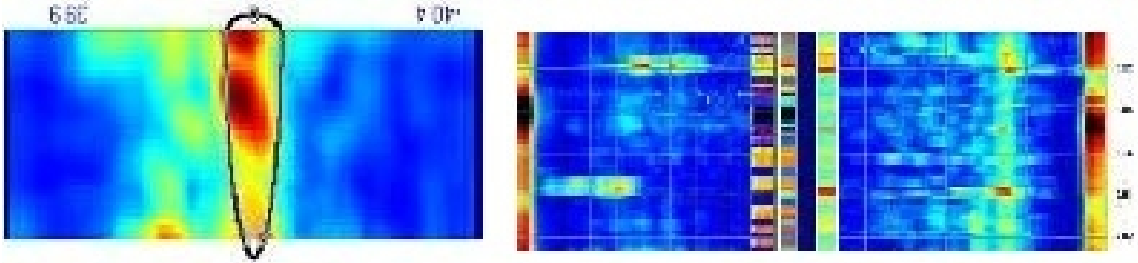
Figure 34: Weld Defect

Figure 34 shows a weld OD defect. This defect was accurately characterized during the tool run, but fell below the initial length threshold; it was therefore not reported as a defect until the threshold was adjusted as described in Section 4.1.

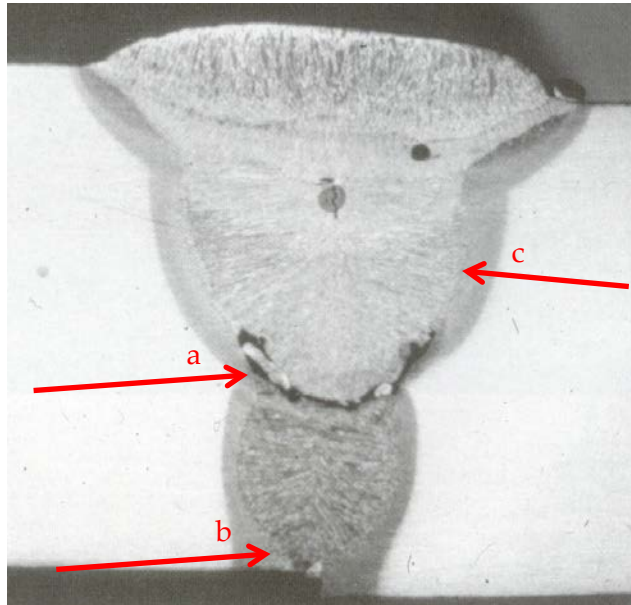
Figure 36: Lack of Fusion

Figure 36 shows incomplete fusion between adjacent weld beads (a). Though not shown in this figure, lack of fusion can also occur at the weld root (b) or the weld sidewall (c).

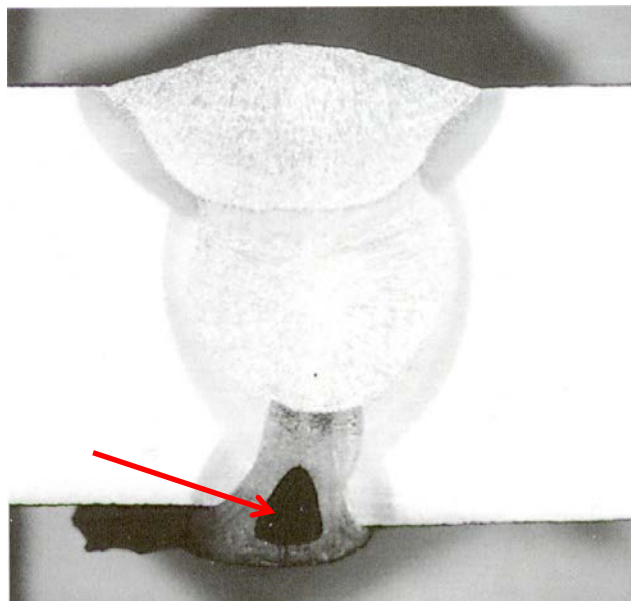
Figure 37: Porosity

Figure 37 shows porosity in the weld root. In the weld root, this means a large continuous pore in the center of the root bead (Macaw's 74). Though not shown in this picture, porosity can take other forms (e.g., clusters of small pores).

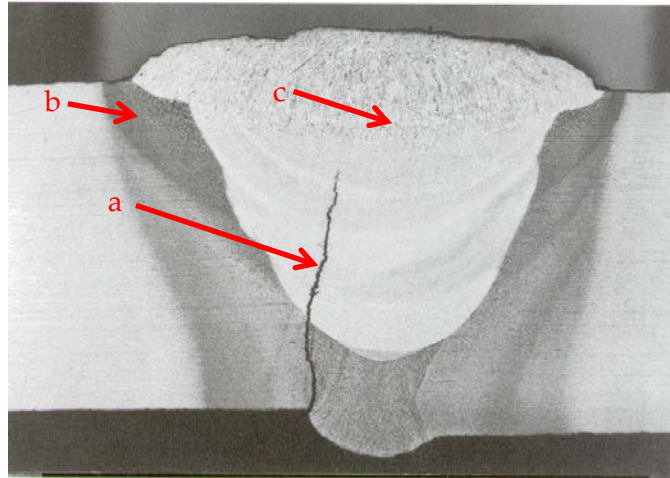
Figure 38: Cracking

Figure 38 shows cracking in the weld root HAZ (a). Though not shown in the figure, cracking can also occur in the weld cap HAZ (b) or in the weld metal itself (c).
